Manhole Inspection Summary

Manhole # S19I__036MH

Insp Date: **2/28/08 11:14 AM**

Location Address: **2002 hollins st**

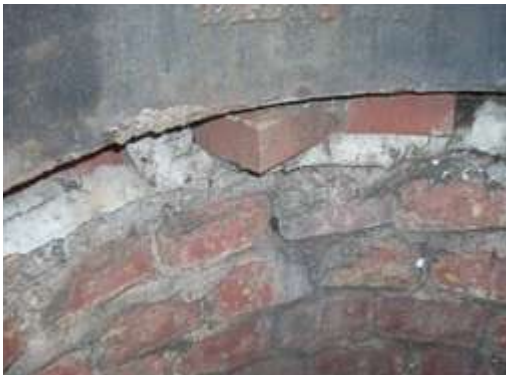
Defect 4

Condition: ☐ Sound ☐ Cracked ☐ Root Intrusion ☒ **Loose Brick** ☐ Deteriorated

loose chimney bricks

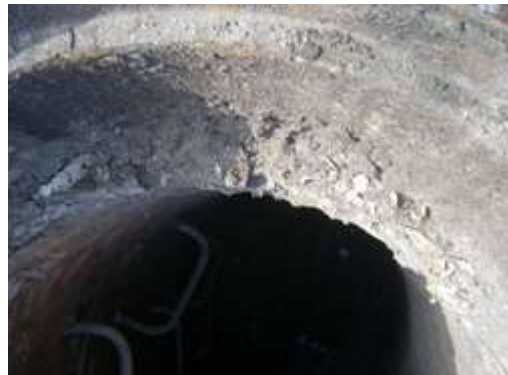
Defect 3

Offset: **2** (in.)

☒ Parged Height: **3** (in.)

chimney parged, frame offset

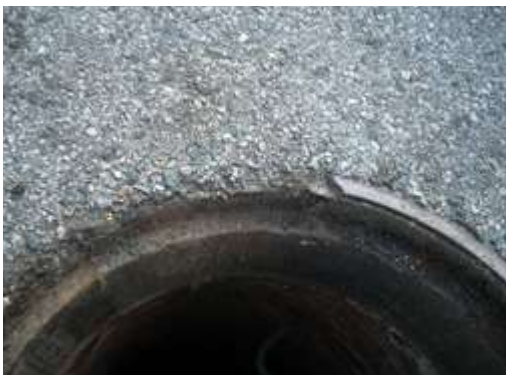
Defect 2

Condition: ☐ Sound ☒ **Cracked** ☐ Leaks

broken frame

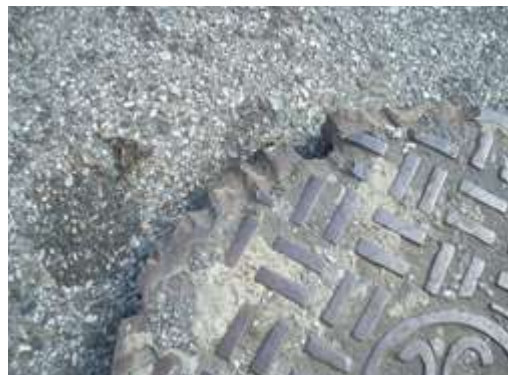
Defect 1

Condition: **Cracked**

cracked cover

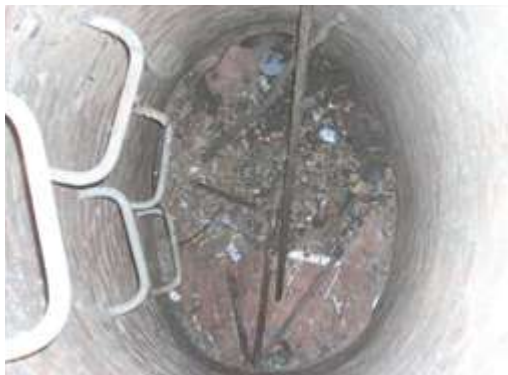
Defect 5

Channel Cond Debris

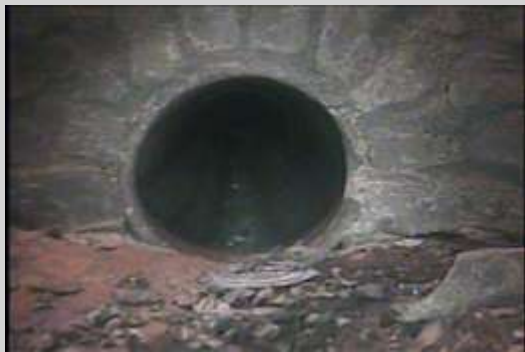
12 O'Clock Outflow

8 in. Circular Gravity Sewer
Pipe Out @ 12 O'Clock

Deposits: ☐ None ☒ **Mud** ☐ Sludge ☐ Debris ☐ Grease

Silt Depth: **0.5** (in.) Deposits Extent: **Light**
